NEW HORTICULTURAL FARM DAM

HOWARD COUNTY, MISSOURI

MO. 10790

**PHASE 1 INSPECTION REPORT
NATIONAL DAM SAFETY PROGRAM**

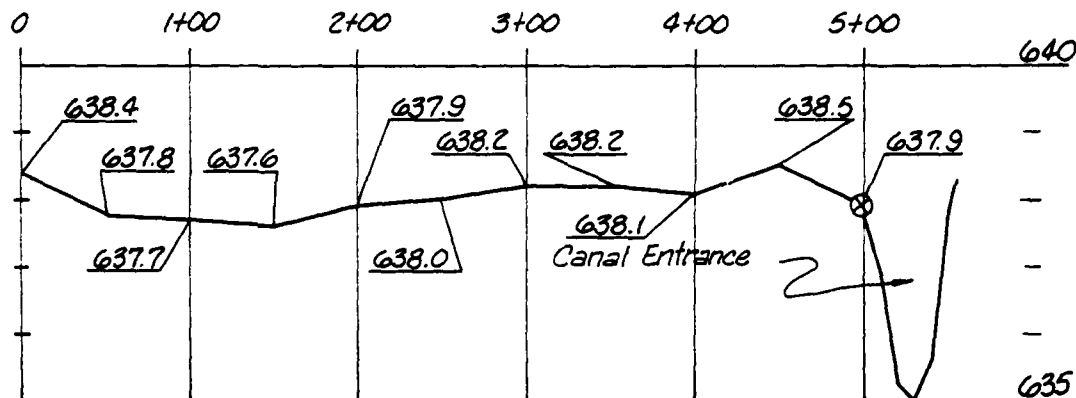
DAM CENTERLINE PROFILE

- (3) Crest. The crest is well vegetated with adapted grasses. The centerline profile is somewhat irregular with a variance of about 2 feet in elevation. No cracks, pot holes, ruts, rodent holes or deformations were noted on the crest.
